Service Bulletin

Subject: Coolant Consumption or Leak

Models: 1995-1997 Buick Riviera
1997-1998 Buick LeSabre, Park Avenue
1996-1998 Buick Regal
1998 Chevrolet Lumina, Monte Carlo
1995-1996 Oldsmobile Ninety-Eight
1995-1998 Oldsmobile Eighty-Eight
1998 Oldsmobile Intrigue
1995-1998 Pontiac Bonneville
1997-1998 Pontiac Grand Prix
with 3.8L Engine (VIN K – RPO L36)

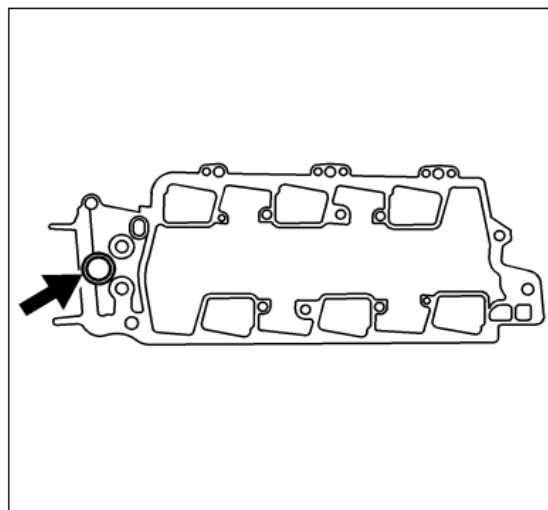
Upper intake manifold composite material may degrade around the EGR stove pipe and could result in an internal or external coolant leak.

2. Refer to the arrow in the illustration of the upper intake manifold above. Inspect the inner diameter of the EGR passage for signs of material degradation. Degradation will appear as "pitting" of the composite material in the EGR port passage.

3. If degradation of upper intake manifold composite material is found, replace the lower and upper intake manifolds.
4. Follow the lower and upper intake manifold installation instructions found in the vehicle service manual.
5. If degradation is not apparent, skip to Step 7.
6. Verify the repair.
7. If no degradation is found, evaluate the vehicle for other causes of excessive coolant consumption as noted in the vehicle service manual.
