# Service Bulletin

**Subject:** Coolant Consumption or Leak

**Models:** 1995-1997 Buick Riviera  
1997-1998 Buick LeSabre, Park Avenue  
1996-1998 Buick Regal  
1998 Chevrolet Lumina, Monte Carlo  
1995-1996 Oldsmobile Ninety-Eight  
1995-1998 Oldsmobile Eighty-Eight  
1998 Oldsmobile Intrigue  
1995-1998 Pontiac Bonneville  
1997-1998 Pontiac Grand Prix  
with 3.8L Engine (VIN K – RPO L36)

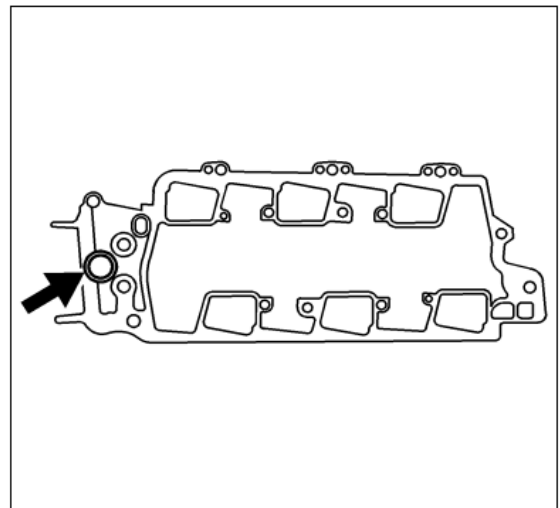
Upper intake manifold composite material may degrade around the EGR stove pipe and could result in an internal or external coolant leak.

2. Refer to the arrow in the illustration of the upper intake manifold above. Inspect the inner diameter of the EGR passage for signs of material degradation. Degradation will appear as "pitting" of the composite material in the EGR port passage.

3. If degradation of upper intake manifold composite material is found, replace the lower and upper intake manifolds.
4. Follow the lower and upper intake manifold installation instructions found in the vehicle service manual.
5. If degradation is not apparent, skip to Step 7.
6. Verify the repair.
7. If no degradation is found, evaluate the vehicle for other causes of excessive coolant consumption as noted in the vehicle service manual.
