Service Bulletin

Subject: Knocking Type Noise From Compressor

Models: 1999-2004 Cadillac Escalade
1990-2004 Chevrolet, Suburban, Tahoe
1990-2004 GMC Suburban, Yukon
with Rear Air Conditioning

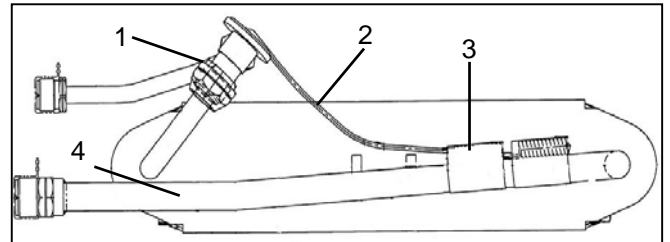
The knocking noise may be due to the TXV remaining open from poor contact between the TXV capillary tube and the rear evaporator outlet tube.

When the rear A/C system is shut off, the TXV remains open creating a liquid refrigerant flood condition through the rear system, causing a sporadic flow of liquid refrigerant to the compressor.

To correct this condition, replace the TXV (1). When installing the new TXV, double clamp (2) the TXV capillary tube (3) to the evaporator outlet tube (4).

Insulate the capillary tube with insulating tape.

Install a new compressor and an inline filter.
