CONI-SEAL®

TECHNICAL SERVICE BULLETIN

TSB# 072604

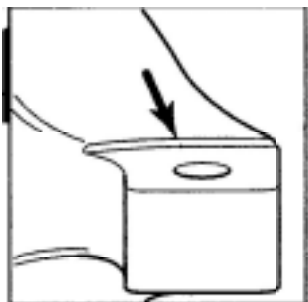
There is an issue with a sharp edge on the casting of the steering knuckle on these vehicles. (Illustration Below) The service bulletin suggest using emery cloth to lightly sand the sharp edge off, so it cannot contact the Tie Rod End grease boot and cause a tear. If this occurs, the Tie Rod End may fail prematurely due to loss of grease.

We will begin including a notice with each Tie Rod End package, instructing the installer of this issue with the Steering Knuckle.
